CO-DIAGNOSTICS: KIBRIS ŞEHİTLERİ STREET

Measuring the Quality of Public Life

Özden P. (2025). Birlikte-Tanı Kıbrıs Şehitleri Caddesi: Kamusal Alan Yaşam Kalitesinin Ölçümü.
İzmir Planlama Ajansı. İzmir Büyükşehir Belediyesi.

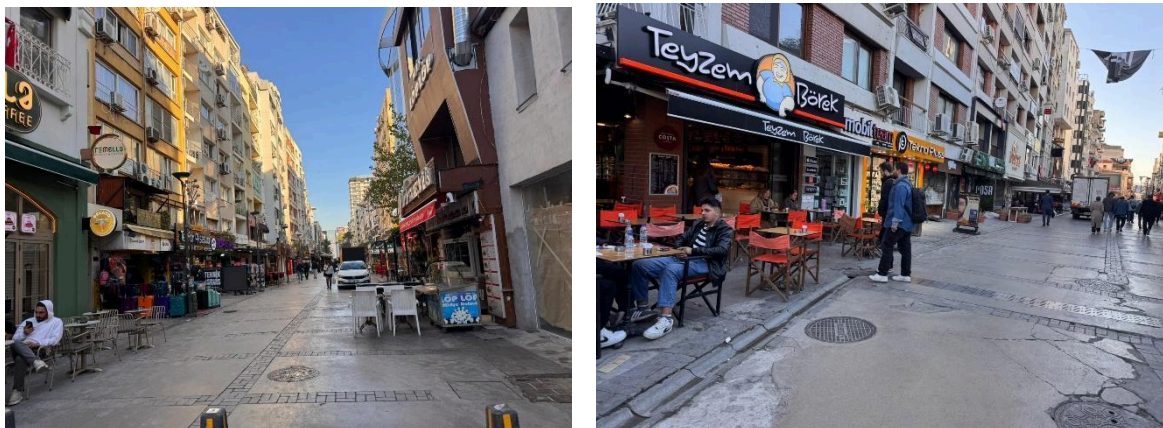
Figure 3: Various Commercial Units

Kıbrıs Şehitleri Street is characterized as a multifunctional public space. It contains various commercial units in the food and beverage, retail, market and food, service, health and pharmacy, and other sectors. As the first stopping point for tourists arriving from Alsancak Port, Kıbrıs Şehitleri Street stands out as an important public space for tourists, local users, and visitors.

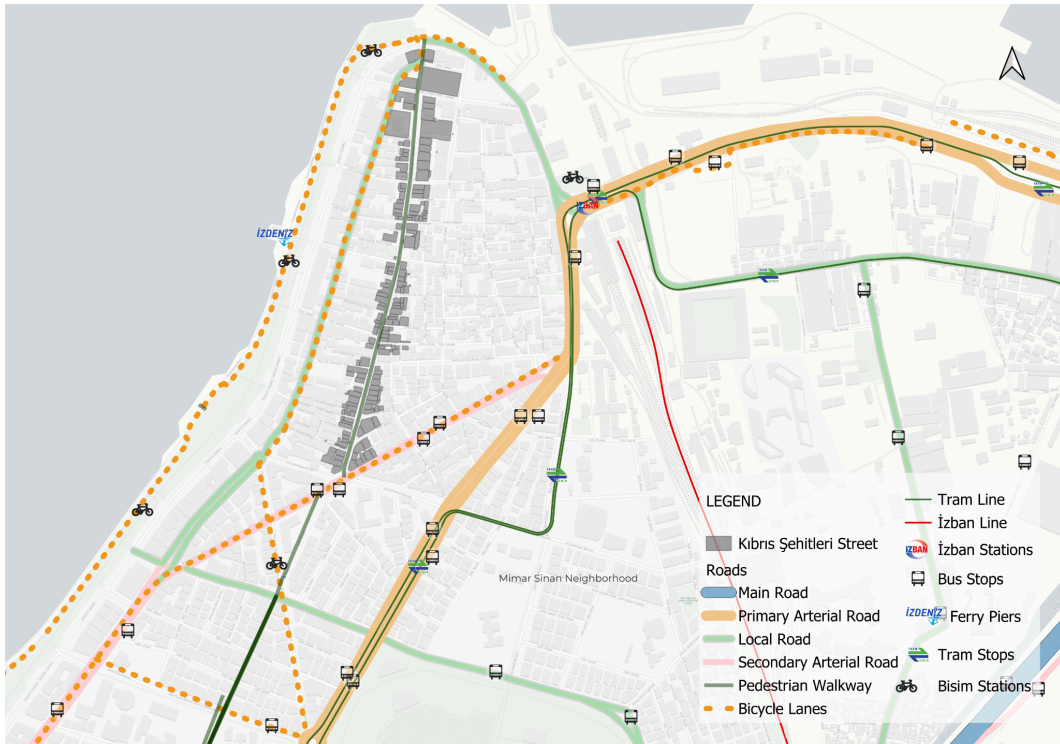
Figure 4: Kibris Şehitleri Street Transportation Connectivity

Access to Kıbrıs Şehitleri Street is provided through various transportation alternatives including private cars, public transport, and bicycles (Figure 4). In the immediate vicinity of the area are a ferry terminal, bus stops, tram stops, and İZBAN stations. The various public transportation alternatives available in the area, together with nearby bicycle lanes, increase its accessibility.

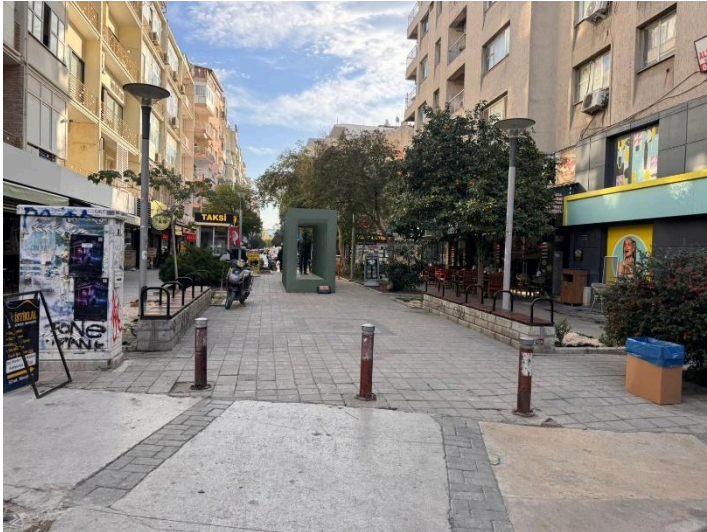
Figure 6: Seating Areas

According to spatial observations conducted on Kıbrıs Şehitleri Street, street furniture in the area was found to be quite limited. There are only a limited number of seating areas in the children's playground and at connection points with side streets such as Mehmet Esat Bozkurt Street. It was also observed that accumulated waste in the area causes hygiene problems.

- **A greener Kıbrıs Şehitleri Street** by reducing the amount of concrete and asphalt surfaces,
- **Seating elements** that were strongly demanded by respondents and that can support activities such as sitting, resting, viewing, socializing, and eating and drinking in public space, thereby increasing the potential for social interaction,

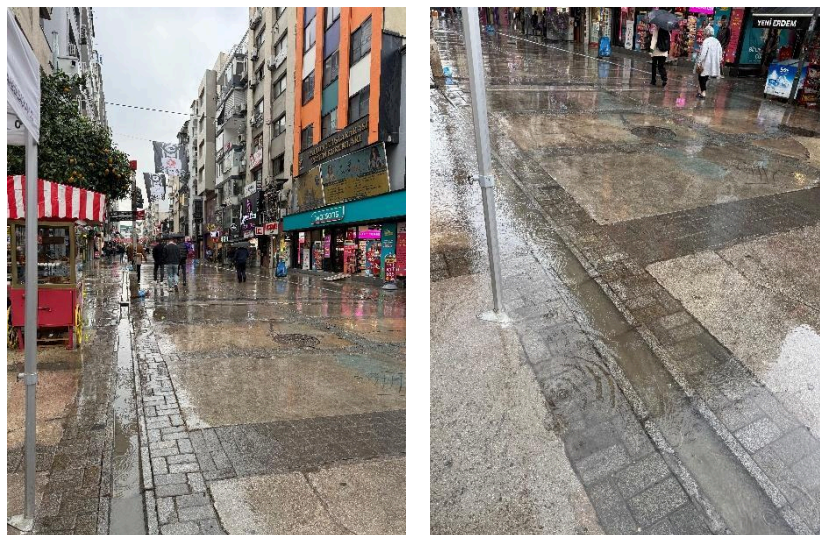
Figure 8: Puddles

Spatial observations conducted on rainy days revealed the formation of puddles in the area (Figure 8). In addition, the absence of enclosed or semi-open public spaces in the area during rainy weather restricts user mobility and reduces spatial comfort for users.

- An **activity area** capable of hosting various cultural and artistic events,
- Developing design elements that **enhance urban comfort in public spaces, such as strengthening infrastructure and improving pavement, and the development of design standards for users with special needs through an inclusive design approach,** in this area, where extreme weather events such as flooding occur.
